Manhole Inspection Summary

Manhole # S13CC_021MH

Location Address: **1200 DUKELAND ST**

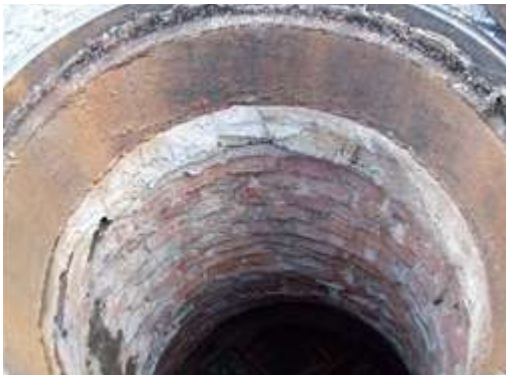
Defect 3

Infiltration: ☐ None ☐ Joint ☒ **Cracks** ☒ **Mortar** ☐ Roots ☒ **Wall**

INFILTRATION AT CORBEL

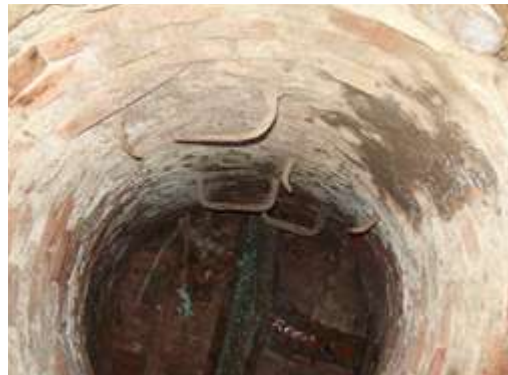
Defect 4

Count: **3** Missing: **1** ☒ **Corroded**

corroded steps

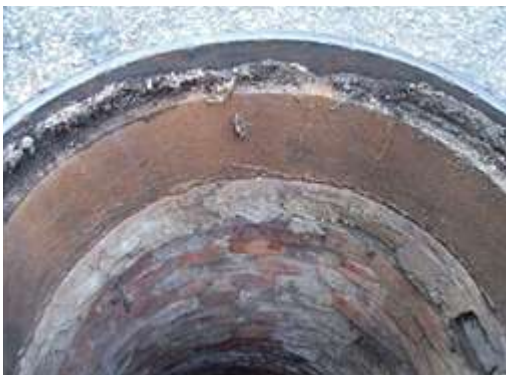
Defect 1

Condition: ☐ Sound ☒ **Cracked** ☐ Root Intrusion ☒ **Loose Brick** ☐ Deteriorated

CRACKED CHIMNEY

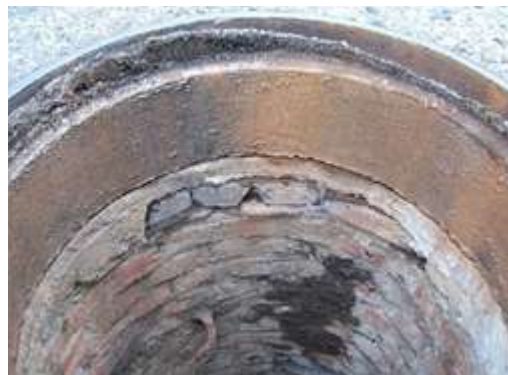
Defect 2

Condition: ☐ Sound ☒ **Cracked** ☐ Root Intrusion ☒ **Loose Brick** ☐ Deteriorated

CRACKED CORBEL-LOOSE BRICKS

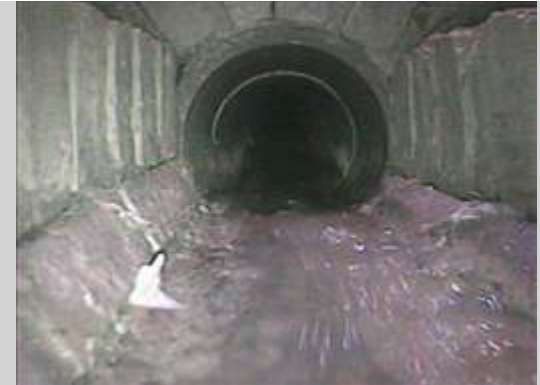
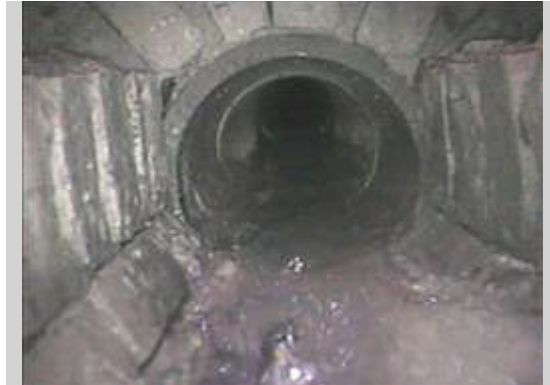
Pipe Out @ 12 O'Clock

Pipe Height: (in.) Direct
Pipe Material: **Clay** ☐ Pipe Lined
Invert Depth: **9.10** (ft.) Flow Characteristics: **Fast**
Deposits: ☒ None ☐ Mud ☐ Sludge ☐ Debris ☐ Grease
Silt Depth: (in.) Deposits Extent:
Infiltration: **None** Pipe Seal Cond: **Sound**

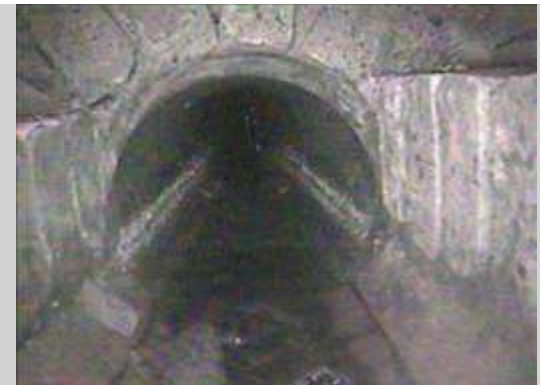
3 O'Clock Inflow

Pipe Height: (in.) Direct
Pipe Material: **Clay** ☐ Pipe Lined
Invert Depth: **9.05** (ft.) Flow Characteristics: **Slow**
Deposits: ☒ None ☐ Mud ☐ Sludge ☐ Debris ☐ Grease
Silt Depth: (in.) Deposits Extent:
Infiltration: **None** Pipe Seal Cond: **Sound**

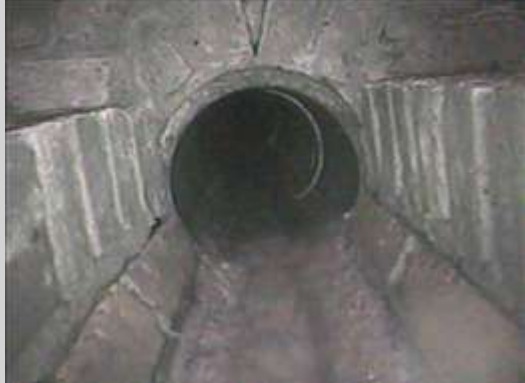
Pipe In @ 6 O'Clock

Infiltration: **None** Pipe Seal Cond: **Sound**
